A Survey of Watershed Quality at Blackacre State Nature Preserve, Jefferson County, Kentucky

Andrea Almeida, Amy Cummins, Phaedra Jones, Susan H. Reigler*
Department of Biology, Indiana University Southeast, New Albany Indiana 47150

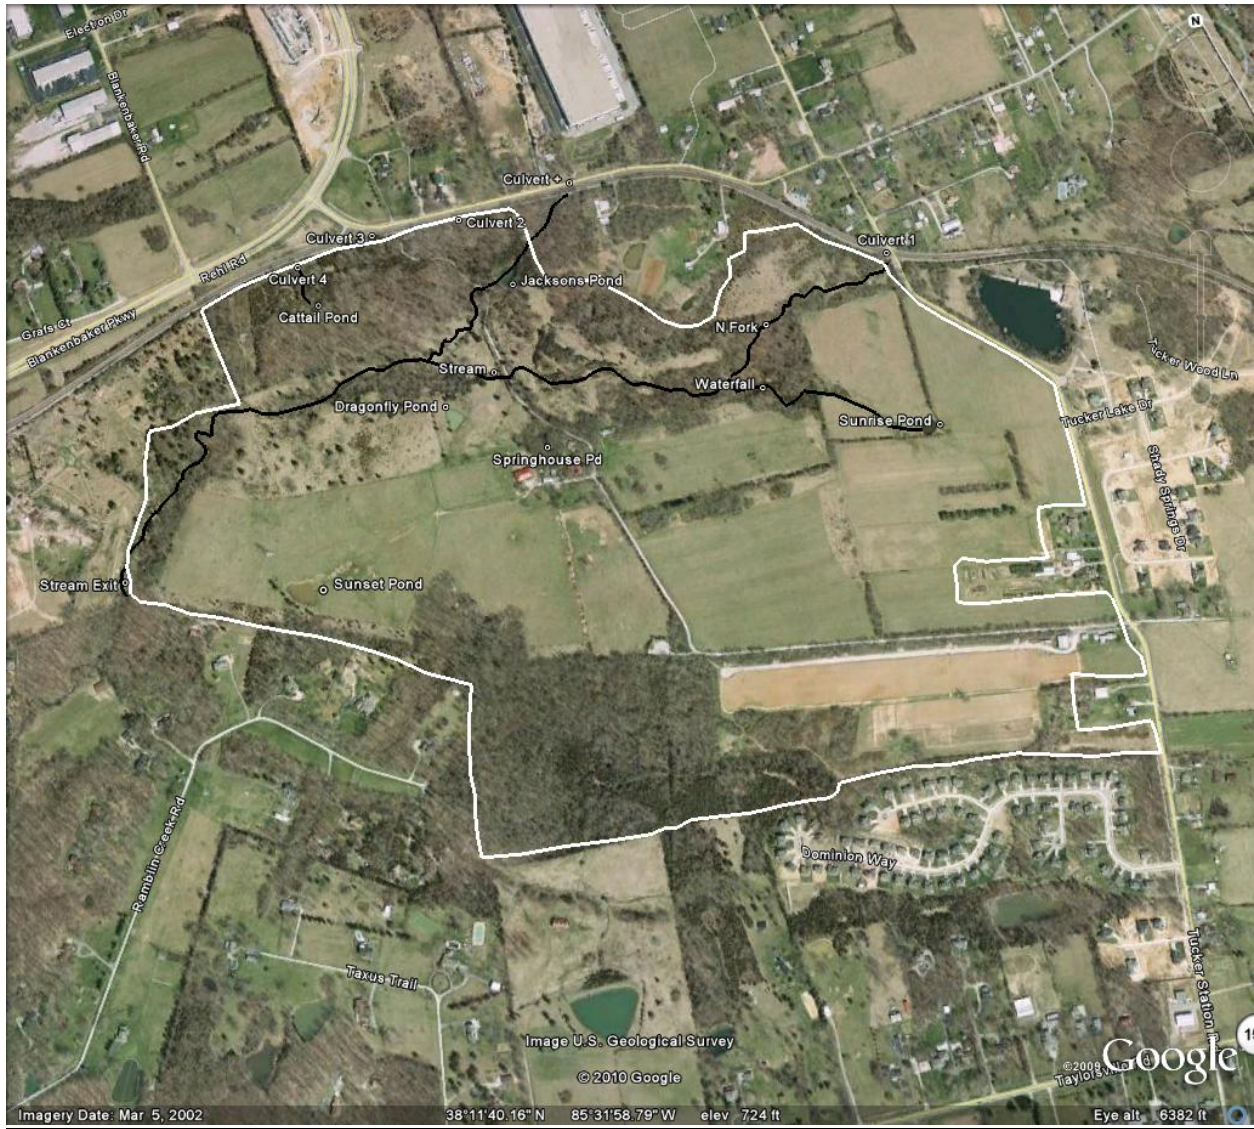
Figure 1. Water sampling points.

Samples were collected from five stream points and from five of the six ponds (Figure 1) over a six-week period from early June to mid-July. At the culverts and the waterfall, water levels were too low to obtain certain data, such as dissolved oxygen. Sample readings were averaged for the reported results. Chemical content was evaluated using Hach Water Analysis Kits. (The sixth pond, Sunset Pond, was reduced to a layer of mud and unsuitable for sampling.) Testing was conducted to measure dissolved oxygen, phosphates, nitrates, ammonia nitrogen, temperature, and pH. The research team also measured water and air temperature. Water clarity was assessed at each site with a 60 cm (15 NTU) turbidity tube. Water hardness – total calcium and magnesium – was determined using WaterWorks hardness test strips. Watershed quality was assessed using protocols of the Hoosier Riverwatch Manual (Indiana Department of Natural Resources, 2010) to determine a Water Quality Index. (WQI). This rating was used in order to have a comparison with ratings from sampling done in March, 2010 by students from Indiana University Southeast that the same Hoosier Riverwatch Manual protocols.

Five storm water culverts positioned under a Norfolk Southern Railroad track have outflows into the northern portion of Blackacre (See Figure 1). One of these, which feeds Jackson's Pond, is on private property. The other four are within the preserve's boundaries. Sedimentation measurements of the water channels of two of the storm water culverts, which have had increased flow rates within the last several months causing erosion and downstream sedimentation, were measured. Measurement was taken by placing metal fence posts in the stream bed, marking the level of the substrate on each and measuring the amount of sedimentation after a .06 inch rainfall.

Several homes to the east and north of Blackacre may have such septic systems, as well as the septic system serving the two dwellings on Blackacre itself. The preserve's system is located near the geographic center of the property and uphill from much of the stream watershed. (See Figure 1.)

High levels of *E. coli* in Jackson's Pond could be coming from storm water. (Moglen, 2000). The pond is fed by a culvert on private property north of Blackacre (marked Culvert + in Figure 1). High counts were also measured at other culverts and in Sunrise Pond. Sunrise Pond is downstream from older homes on Tucker Station Road.

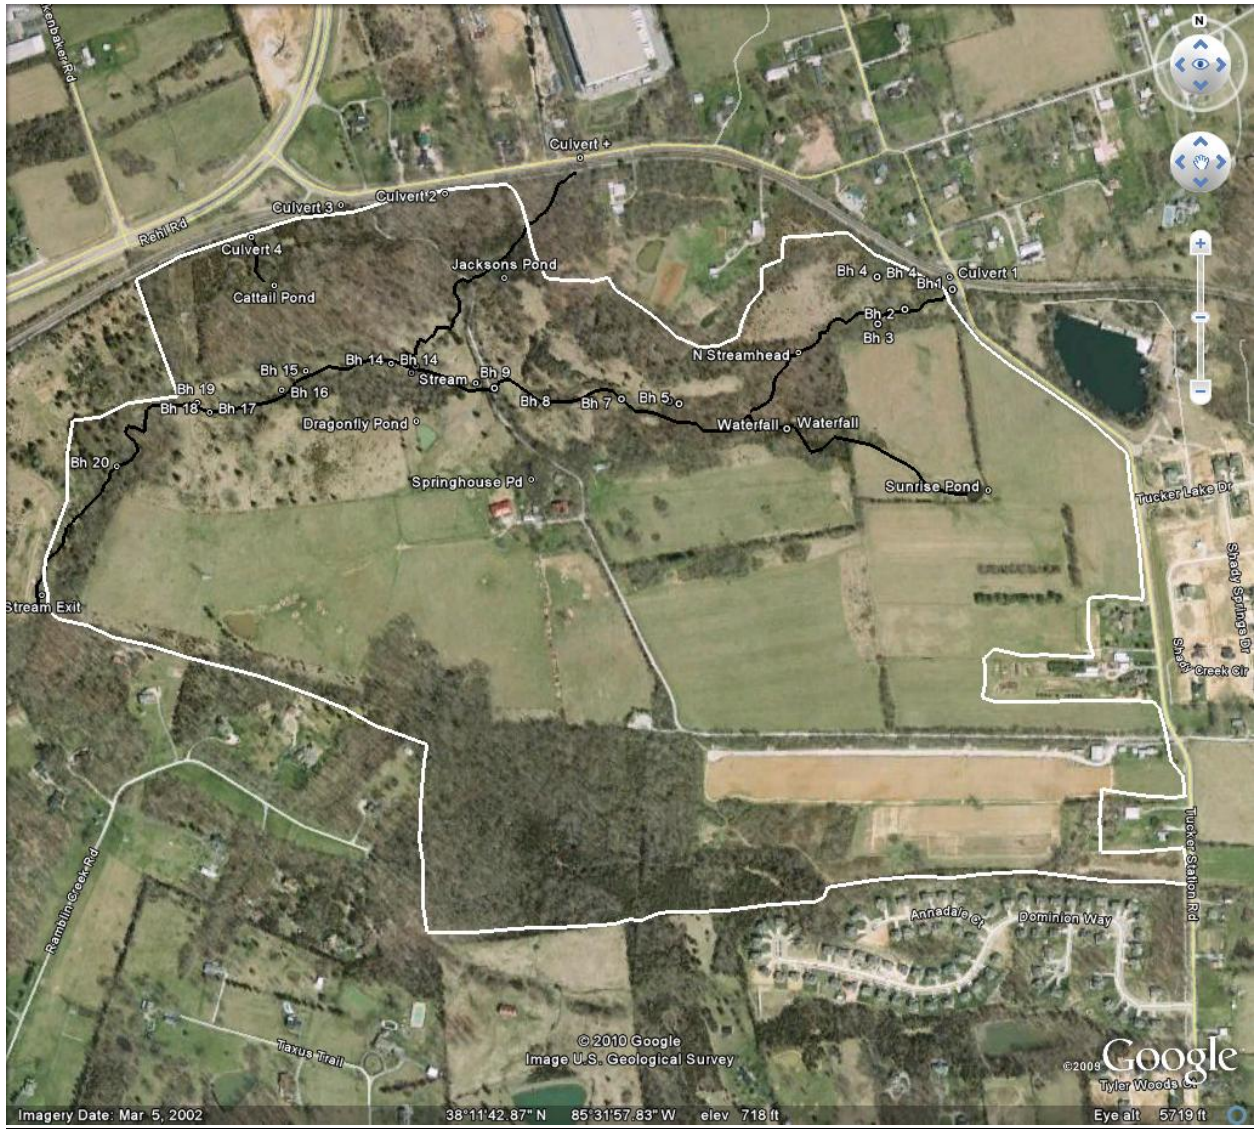
Figure 2. Bush Honeysuckle in Riparian Zone. Bh=presence of plant.

The invasive plant species, bush honeysuckle (*Lonicera maackii*), is unfortunately found on much of the Blackacre State Nature Preserve. The presence of bush honeysuckle along the banks of the stream was tracked and noted using the Garmin handheld GPS. Each point was labeled Bh, for bush honeysuckle, and assigned a sequential number. Each labeled point was then assigned a level of density rating (1-little to no bush honeysuckle present, 2-bush honeysuckle present, but sparsely populated and mostly below 5 ft. in height, 3-densely populated bush honeysuckle of varying heights and widths).

Using the level of density rating (Levels 1-3, as established in Methods) for determining the presence of bush honeysuckle, it was found that 58.5% of the stream banks contain densely

populated areas of mature bush honeysuckle (Level 3). Another 37.5% of the stream had areas of sparsely populated bush honeysuckle, both young and mature in size (Level 2). Only 4% of the stream banks were found to have little to no bush honeysuckle presence.

There are at least four sampling points (Bh 14, 16, 18, and 19) where removal would be ill-advised. Honeysuckle growth was so dense at Bh 14 and 19 that removing them all would cause bank instability. Bh 16 and 18 had steep embankments on one side of the stream bank where erosion would certainly increase if any vegetation were removed. Any control must be

The presence of Amur bush honeysuckle along a large portion of the stream degrades the stream habitat quality. Trained personnel, professional and/or volunteer should be engaged to remove as much as is possible without damaging the stream bank.

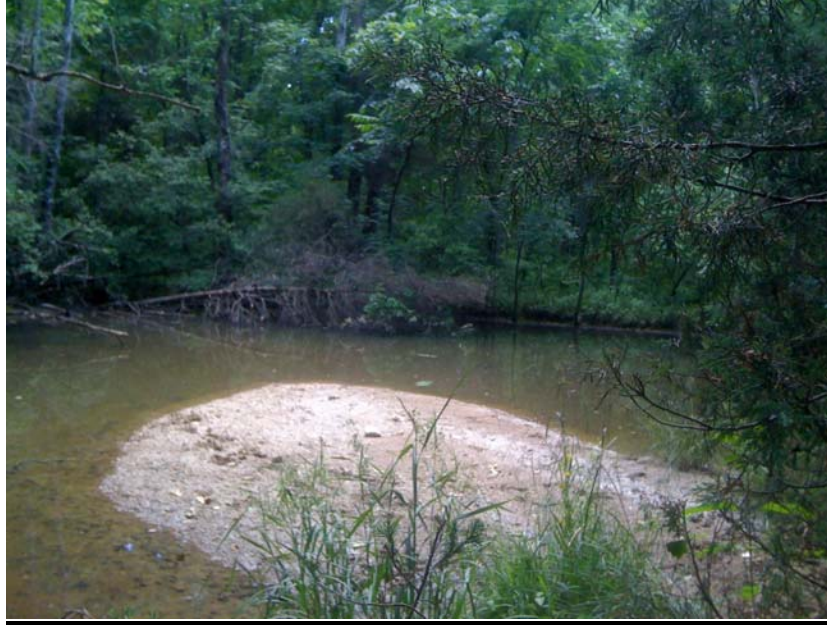
Erosion is a concern in the northern part of the watershed. Deep channels, in some places up to three meters, have been carved out by water from outflows of Culverts 3 and 4. Roots of large trees along the channel banks have been exposed. Most striking has been the siltation of Cattail Pond. In fall, 2009, the pond, while shallow, supported a variety of organisms including insects and frogs. Currently the pond supports almost no macroinvertebrates and no vertebrates. (Figures 3 and 4).

Figure 3. Cattail Pond in June, 2010 showing siltation.

Since the Commonwealth of Kentucky owns Blackacre State Nature Preserve, a staff member of the Kentucky State Nature Preserves Commission has already contacted Norfolk Southern Railroad (builders of the culverts) and the Metropolitan Sewer District (which monitors surface water movement) about mitigating the increased flow through Culverts 3 and 4. This will include the placement of rock out the outflows to slow flow rates. Restoration of Cattail Pond is a concern that will require further study.

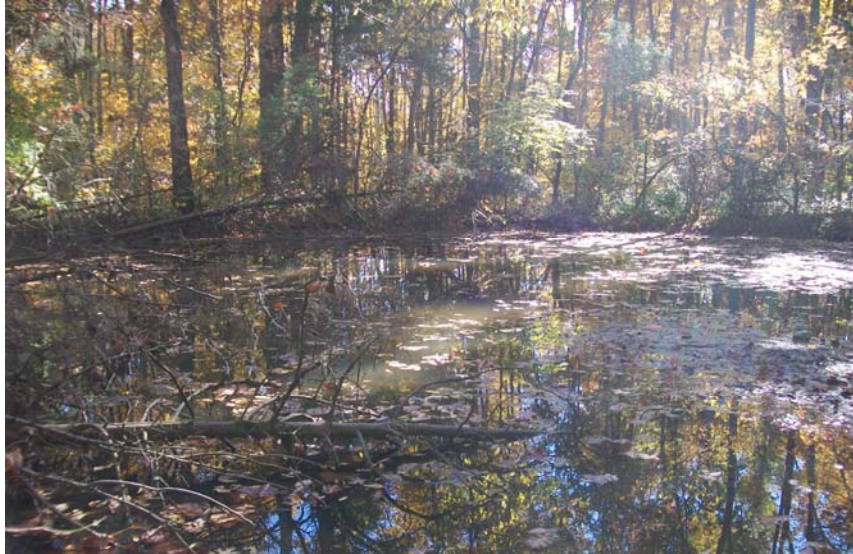
Figure 4. Cattail Pond in October, 2009 showing no siltation.
