# A SURVEY OF WATERSHED QUALITY AT BLACKACRE STATE NATURE PRESERVE, JEFFERSON COUNTY, KENTUCKY

Andrea Almeida, Amy Cummins, and  
Phaedra Jones

Indiana University Southeast

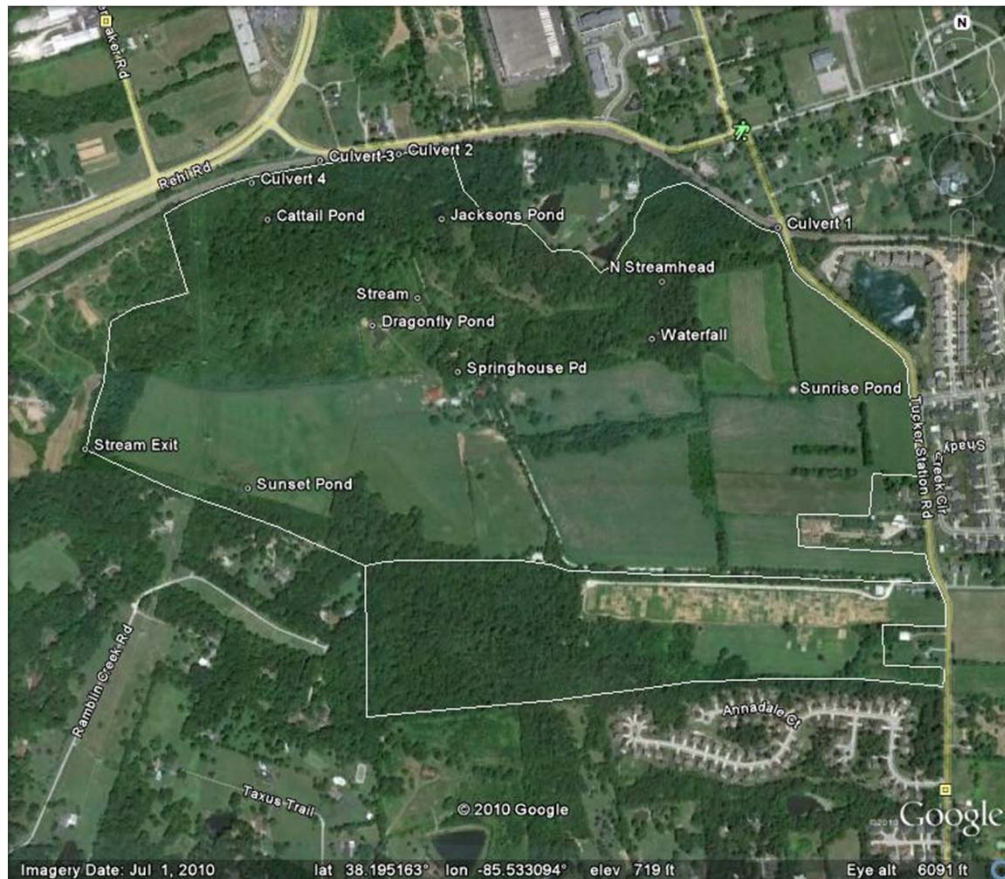
## Points Surveyed

Google Earth image, July 1, 2010

- Sunrise Pond
- Jackson Pond
- Springhouse Pond
- Cattail Pond
- Dragonfly Pond

- Culverts 1-4

- Stream (testing points included)
  - Beginning
  - Waterfall
  - Bridge
  - Exit

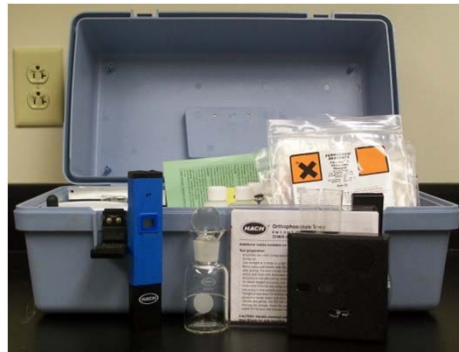
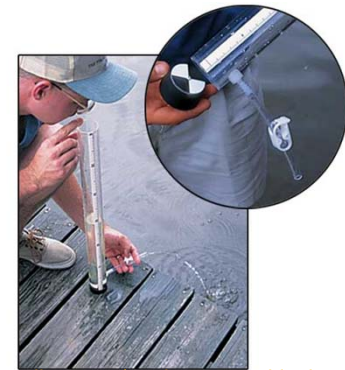
- Chemical Testing - using Hach Water Analysis Kits

1. Dissolved Oxygen
2. Orthophosphates
3. Nitrates
4. Ammonia Nitrogen

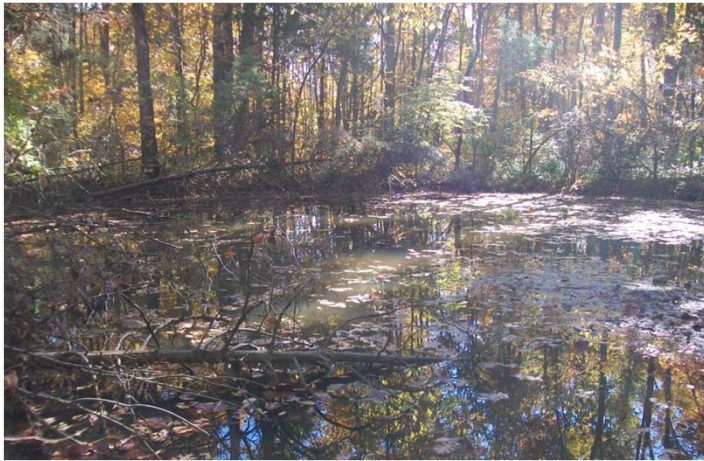
Cattail Pond in October, 2009 showing no siltation.

- Wear latex gloves when handling water
- Service septic tanks on property
- Reduce number of livestock at Blackacre
- Mitigation of flow from culverts
- Possible future restoration of Cattail Pond
- Annual surveys to monitor water quality

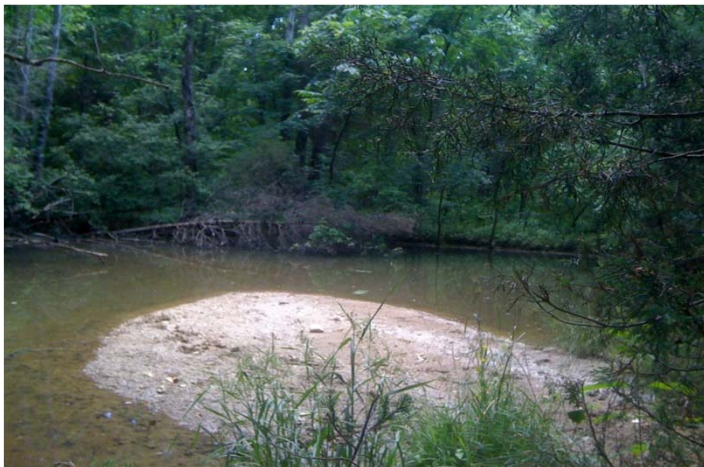
Cattail Pond in June, 2010 showing siltation.

<u>Cattail Pond</u>	<u>Culvert 4</u>
<i>E. coli</i> (colonies/100mL)	260.0	1620.0
Air Temperature (°C)	24.4	24.4
Water Temperature (°C)	27.0	31.0
Dissolved O <sub>2</sub> (mg/L)	3.4	-----
pH	7.5	8.3
Hardness (mg/L)	250.0	425.0
Orthophosphate (mg/L)	0.25	0.14
Nitrates (mg/L)	0.0	0.25
Ammonia Nitrogen (mg/L)	0.0	0.3
Turbidity (NTU's)	15.0	-----
WQI	64.0	59.5
PTI	2.0	-----
